# City of Rockville ADA Access Audit and Transition Plan:

#### REPORT TO MAYOR AND COUNCIL

PRESENTED FEBRUARY 22, 2016 BY JOHN N. MCGOVERN, PRESIDENT, RECREATION ACCESSIBILITY CONSULTANTS LLC

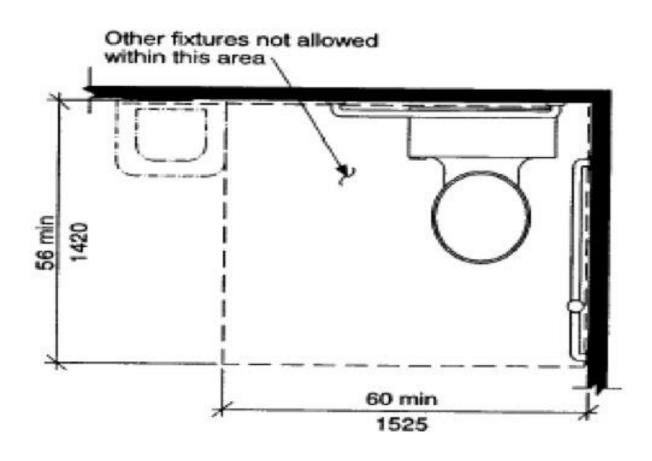
# Single user restroom key change: maneuvering clearance

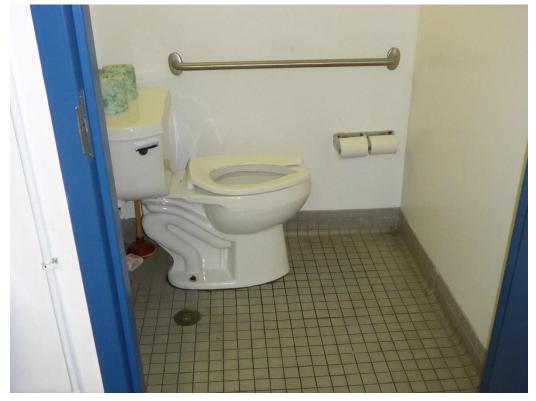
F Scott Fitzgerald Theater- Women's Dressing Room 52"x52"

If single user restroom is not accessible, are the dimensions adequate for retrofit renovation? (min 84" X 60")?

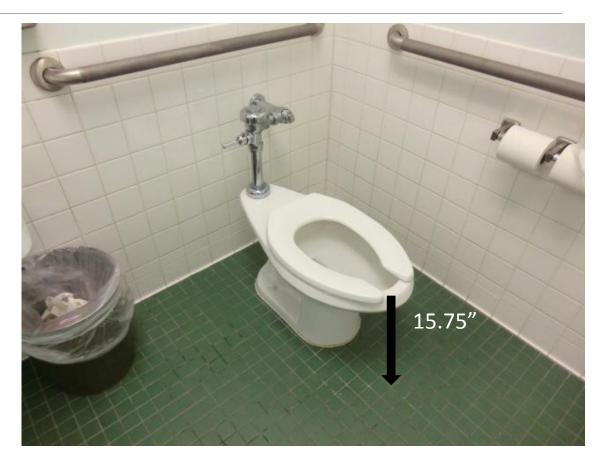
Lincoln Park CC

An obvious key is how the assets were installed. Is the seat height of the toilet 17" min to 19" max? Is the toilet paper 7" to 9" from the front of the toilet?

Another key is maintenance. A simple issue, but the garbage can cannot be in the clear floor space adjacent to the toilet.

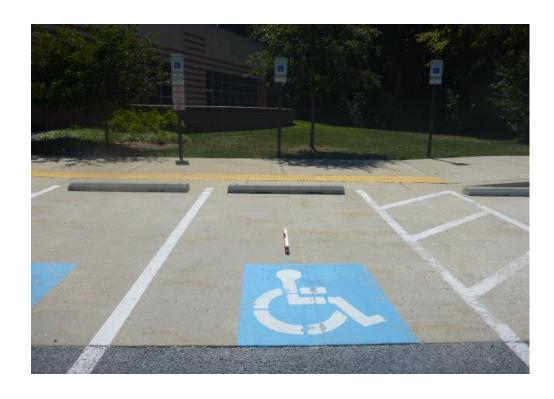
Thomas Farm CC

At Thomas Farm, this accessible parking stall is almost perfect. Width, markings, signs, adjacent access aisle, leads to accessible route, and closest proximity to site assets.

The slope exceeds the maximum, which is 2.08% in any direction. Here it is 2.3%.

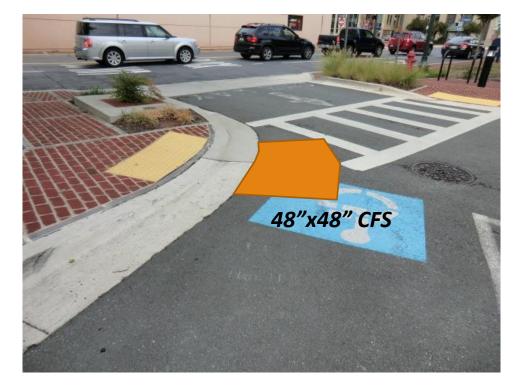
New Police Station-Annex- Sole Deficit

Are parking spaces and the adjacent access aisles designed so that cars and vans, when parked, cannot obstruct the required clear width of adjacent accessible routes?

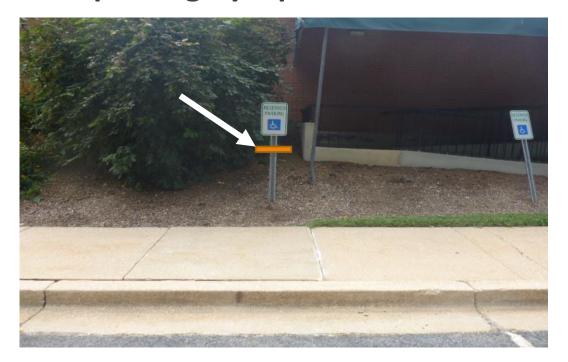
Senior Center

Does each accessible parking stall post or stalk for signs include a sign that notes the fine for parking by a person without a disability?

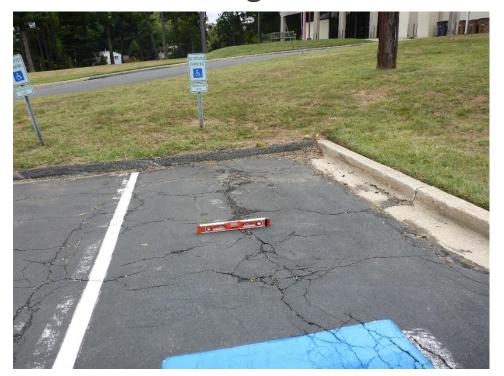
F. Scott Fitzgerald Theater

Is the bottom edge of the lowest sign at least 84" above the ground?

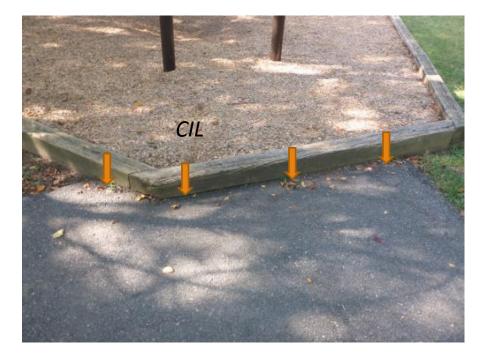
Kinship Park

Does the playground have a designated entrance to both elevated and ground level play components?

Are all changes in level <1/4"?

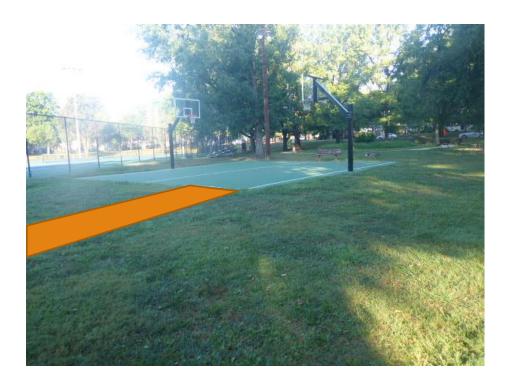
Woodley Gardens Park

Is there an accessible route to the element? An AR should be firm, stable, and slip resistant. Grass is never considered an AR.

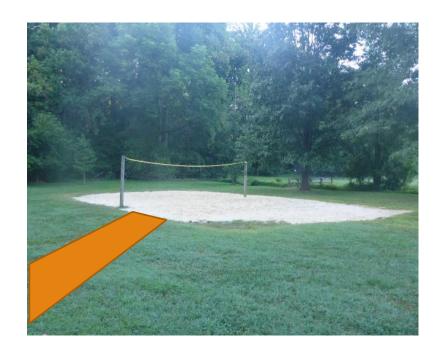
Woodley Gardens Park

Is the element designated for wheelchair use?

(i.e., surface, reach range, etc.)

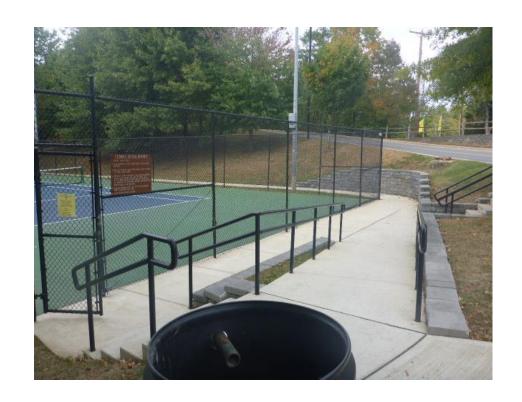
Is there an AR to the element?

Here the tennis courts are accessed by ramp, or stairs only.

Do all ramps have a slope no steeper than 1:12 (8.33%)?

Here it is 10.3%

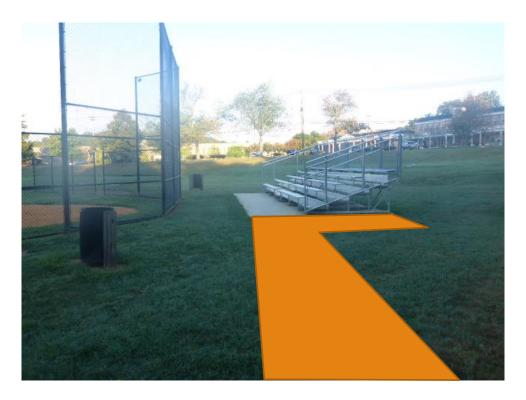
**Woodley Gardens Park**

Does the AR extend to spectator seating?

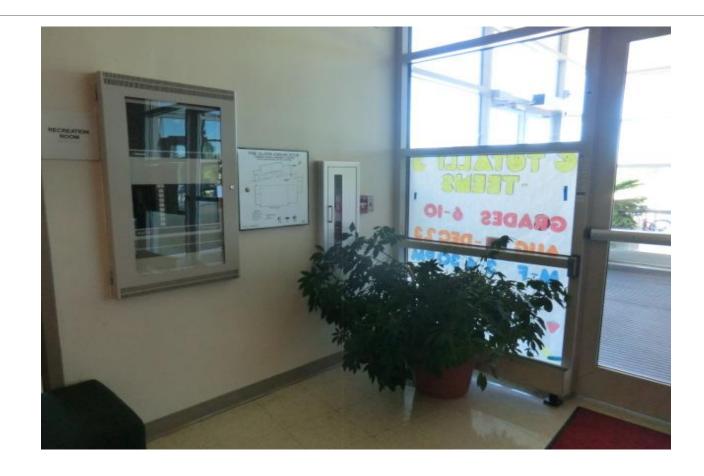
Operable parts should have clear floor space for access

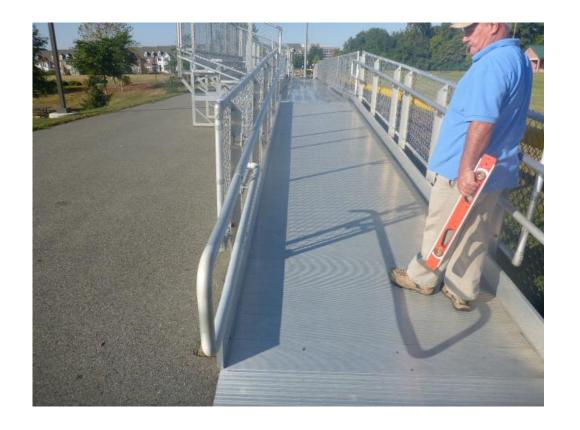
Ramps for access to bleachers at Mattie Stepanek Park
